Plan Commission Minutes

Town of Washburn

Section 29 Closed Landfill, South Maple Hill Rd.
Sunday, October 16, 2022

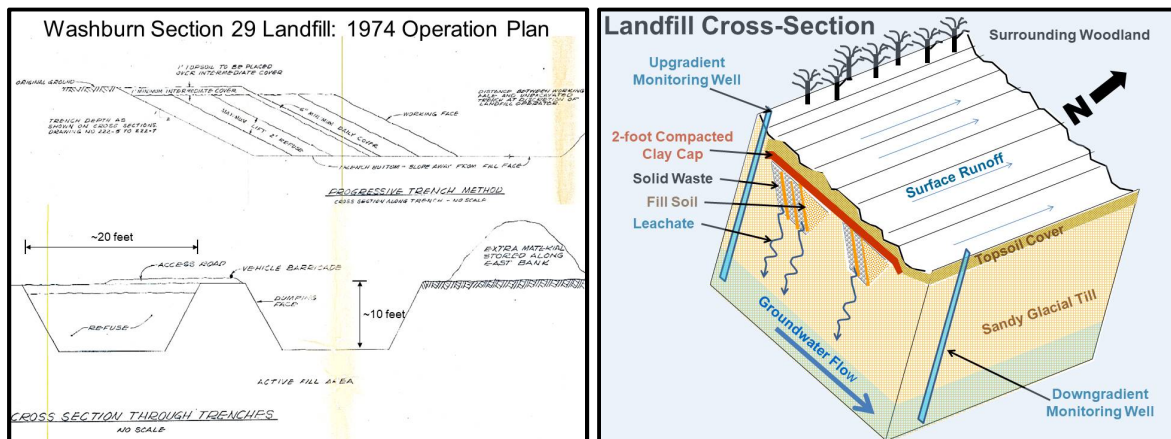
Kim shared a drawing the proposed operation of the landfill from 1974 and a conceptual cross-sectional view of the closed landfill's current condition. The landfill operated as a series of north-south trenches in the sandy soil approximately 500 feet long, 20 feet wide and 10 feet deep. Trenches were excavated sequentially from west to east. As one trench was excavated and filled with solid waste, it was compacted and covered with two feet of sand, and the next trench was excavated to the east and filled. Municipal solid waste was disposed in the trenches for 15 years from 1975 through 1989. There is no impervious barrier at the bottoms of the trenches. Any leachate leaking from the waste seeps into the sandy soil below. The bottoms of the trenches are approximately 250 feet above the groundwater table.

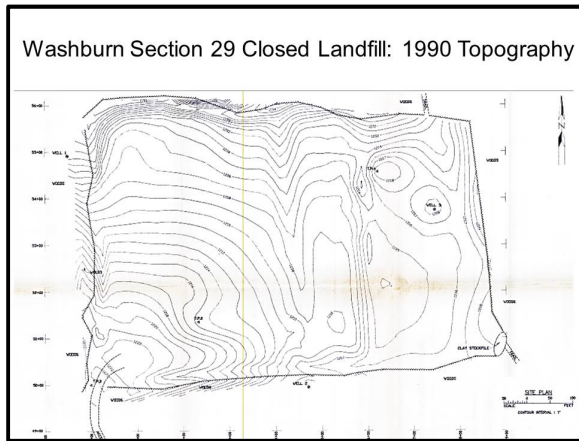
Kim shared two figures comparing the topography of the landfill cap in 1990 vs 2020. What were smooth contours with a drainage swale in the east third of the cap is now much more “lumpy,” likely from the decay and compaction of municipal solid waste below the cap. The most severe such depressions are on the east side of the landfill. They subsided at least two feet. The cattails growing in them is an indication that they form ponds of standing water for a substantial part of the year. Surface water flows to the north, and groundwater flows to the east toward Lake Superior. The elevation of the water table in Monitoring Well #1 (on the west) is approximately 3 feet higher than that in Monitoring Well #3 (on the east) and approximately 1 foot higher than Monitoring Well #2 (to the south).

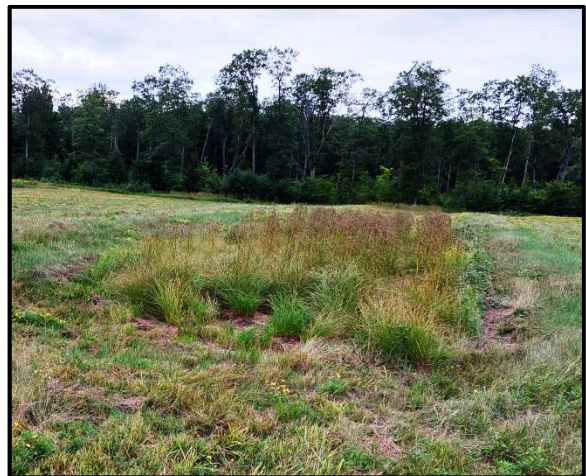
Kim explained how a clay cap functions. Clay is not impervious but rather is very weakly permeable. Surface water flows through the clay and into the buried waste, but the clay is expected to minimize the rate of leachate flowing into the groundwater so that concentrations of landfill contaminants in groundwater will remain low as the groundwater flows east away from the landfill site. The six-inch cover of topsoil over the clay cap provides a medium for grassy groundcover that prevents erosion of the clay cap and it is contoured to direct surface water flow off of the cap without flowing so fast that gullies are formed. The topsoil cover is intended to hold enough moisture to reduce the likelihood of the clay drying and cracking. Any cracks in the clay are potential conduits that carry larger amounts of surface water into the waste and increase the rate of leachate flow to groundwater.

Cattail depression in clay cap.

Regular mowing of vegetation on the cap is intended to minimize the potential for deep-rooted vegetation from penetrating the cap and creating additional conduits for water to seep into the waste too rapidly. As solid waste under the cap decays and becomes more compacted, the clay cap will subside. These areas of subsidence may reduce the rate of surface water runoff and may even allow water to pool over the clay. These lumps and pools on the surface of the cap increase the rate of leachate seeping into the groundwater. Cracks in the clay may also occur around areas of subsidence. The groups saw several cracks in the soil around these depressions, but it was not clear that the cracks extended through the clay cap.

Other potential sources of damage to a cap are 1) vehicle traffic that may cause ruts in the surface, 2) deposition of rocks, boulders, or other debris, and holes created by burrowing animals. The group could only guess where the boundaries of the clay cap are and recommended that testing with small soil cores be done to prevent encroachment and disturbance of the cap and to assure that the entire cap area is mowed.

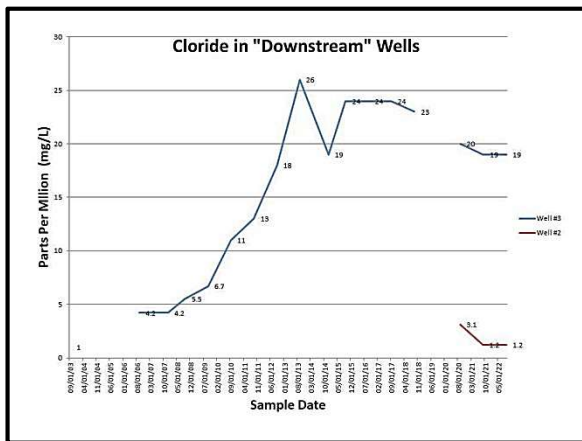
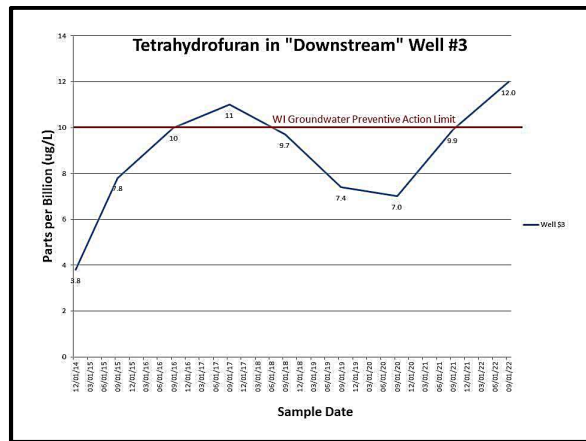
Kim had compiled groundwater sampling data from the Wisconsin Department of Natural Resources online database of landfill groundwater data (GEMS) and showed two graphs to illustrate how landfill leachate is affecting groundwater. Scott mentioned that sampling recently occurred in September, and Kim added the data Scott shared to the graphs shown below.

Chloride concentrations are a general indicator of the “saltiness” of the water. At a few parts per million (mg/L), it is not a substance of health concern but rather indicates that landfill leachate is in groundwater. It is not detectable in the “upstream” well (#1) on the east, but started to be detectable in the “downstream” well (#3) in 2003. Concentrations rose steadily to a peak of 26 mg/L in 2013 and now are leveling to approximately 20 mg/L recently. Kim said, to think of a leachate plume, as a trickle of colored water in a slowly flowing stream: the color spreads and fades as the colored liquid diffuses and slowly flows downstream. It took several years after waste was placed in the landfill for the salty leachate to be detectable in Well #3.

Six organic solvents have been detected in the “downstream” well (#3), but only one solvent occurs at levels that can be quantified in laboratory tests: tetrahydrofuran. The Wisconsin Groundwater Standard for tetrahydrofuran is 50 parts per billion (µg/L), and the Wisconsin Preventive Action Limit is 10 µg/L. Kim explained that a one part per billion concentration is approximately one drop mixed in a large tanker truck of water. In other words, a very small amount in solid waste can contaminate groundwater at levels of health concern. The solvent is used as an adhesive in PVC pipes since the 1970s and as a solvent in lacquers. The chemical vaporizes and degrades rapidly in well ventilated areas, but it degrades very little in groundwater. The state standard is based on the chemical’s potential effect on fetal development.

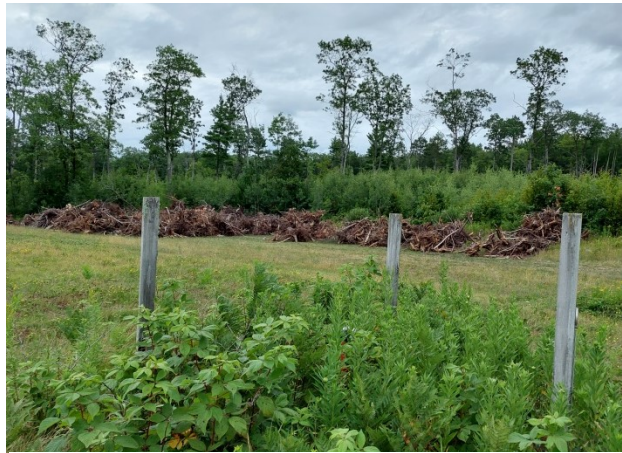
The group observed several tree stumps excavated from the realignment of South Maple Hill Road that were stacked east of Monitoring Well #3 and a pile of soil from the project. Several suggested that it would be appropriate to mark clearly the boundary between the landfill site (a shared responsibility of the town, the city, and the Town of Bayview) and Town of Washburn property outside of the site. The group asked to be informed about what follow-up maintenance is to be done.

Stumps east of Monitoring Well #3.
